FORENSIC ENGINEERING

Joost Walraven
Em. Prof. Delft University
of Technology,
Faculty of Civil Engineering

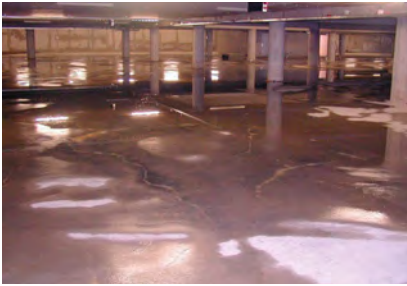
Fig. 1. Leaking floor in an underground parking house due to ignoring the effect of imposed deformation

Fig. 1 shows the floor of an underground parking garage made in reinforced concrete.

The floor has been designed for the load of the cars and on the upward pressure of the soil water, which can increase in winter. The floor was cast in summer; the mean temperature in winter is lower and, moreover, the floor is subject to shrinkage. Free shortening, however, is not possible because of the heavy columns, which are connected to foundation blocks in the sand below the floor. Because the design did not take account of shortening of the floor in its plane and its restraint, large cracks in the structure occurred through which the soil water could easily propagate from below.

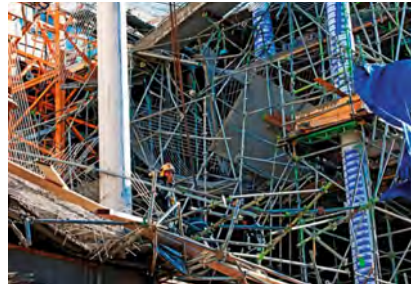
Fig. 2. Collapse of a shopping centre under construction due to an unstable scaffolding system

Fig. 2 shows the collapse of a part of a shopping centre under construction (Rotterdam, 2010). When casting the

third floor, the scaffolding system failed. It turned out that this was due to the absence of a significant part of the bracings in this system that should ensure stability. According to Terwel (2014), an advisor of the supplier noticed this and warned, but no amendments were introduced. The main contractor asked for a final check, but this was not carried out. According to Terwel, “the underlying factors of this case are a lack of technical competencies of the assembly team, unclear responsibilities regarding structures, insufficient risk management for the temporary structure and inadequate checking. No party felt responsible for the quality of the supporting structures”.

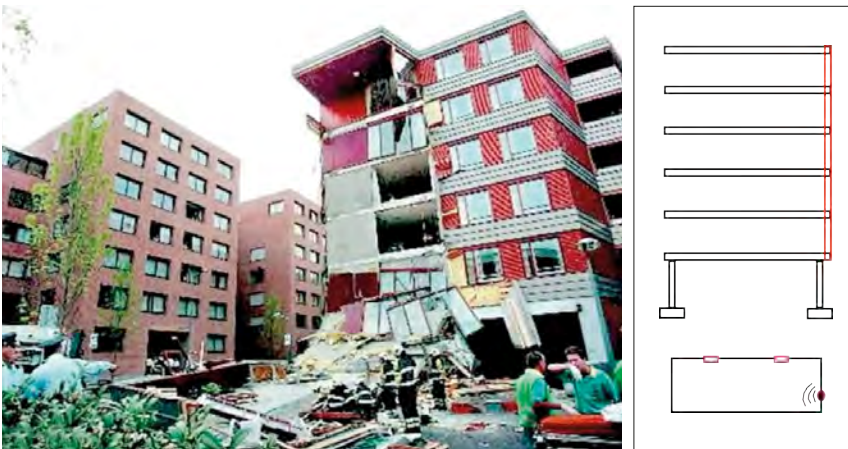
Fig. 4. Progressive collapse of a series of balconies in a high rise building, Maastricht 2003

Fig. 4 shows the example of a series of balconies which failed through progressive collapse (Maastricht 2003). The balconies were supported only at one side by a steel column (Fig. 4 top right). The forces were all transmitted to the lower column at the 1th floor, which was supported by a corbel with inappropriate reinforcement detailing. This corbel failed in shear, resulting in the progressive collapse of the whole series of balconies. The first obvious cause of the failure was the inappropriate detailing of the corbel and the risky support of balconies on a single corbel. Those can be regarded as errors on a micro-level, but a further consideration reveals that also on the meso- and macro levels errors have been made. The full survey is:

1. Micro-level:
 - Errors in detailing of the corbel
 - Insufficient robustness of the structure
2. Meso-level:
 - Insufficient communication between the designer, construction team and the producers of the precast balcony slabs
 - Insufficient steering of the process (too many independent partners)
 - Inadequate reaction to warning signs of the structure during construction
 - Responsibilities not clearly defined
3. Macro-level:
 - Too small capacity of control authorities
 - Insufficient skill
 - Too many subcontractors
 -

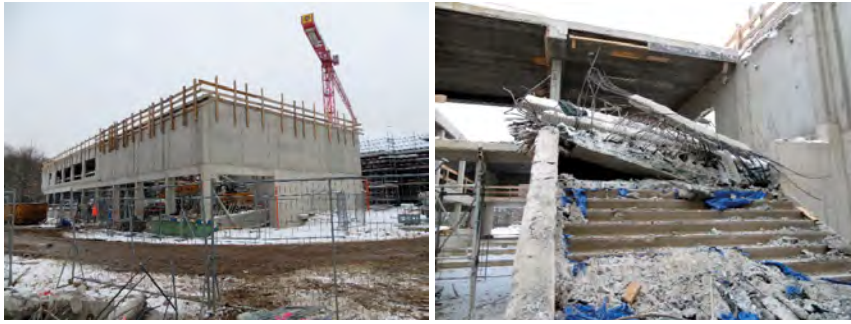
Fig. 5. a) School building under construction, b) Collapse of roof for auditorium, c) Cross section of prestressed beam, d) Side view on prestressed beam with web openings

the table of a code committee. Especially when compromises have to be made between different countries, like in the case of the Eurocodes, the resulting rules do not fully reflect a rational model of the physical behavior. Furthermore, the rules are simplified so that the designer only has to make a number of checks. An example is the design in shear, where shear forces are represented by shear stresses in cross-sections, which hide the real behavior. So, the designer knows the rules but not the truth behind them. An illustrative example is given in Fig. 5, showing the collapse of a roof of a school under construction. Fig. 5a shows a part of the building under construction. Fig. 5b shows the collapse of the auditorium roof during construction. Fig. 5c shows a cross section of the prestressed beam that should carry the auditorium roof and Fig. 5d shows a side view of the same prestressed beam, with large web openings. In the construction stage the beams are placed in parallel so that the lower flanges form a closed plane on which in-situ concrete is cast. Through the web openings transverse reinforcement connects the beams. After hardening of the in-situ concrete, a composite roof with a large bearing capacity is obtained. The problem, however, is the situation just after casting the in-situ concrete. In this situation the beams have to carry the fresh concrete, which only contributes to the load and not yet to the strength. The shear capacity of the beam is decisive here. However, the large web openings prohibit the formation of truss action, because the inclined compressive struts cannot develop.

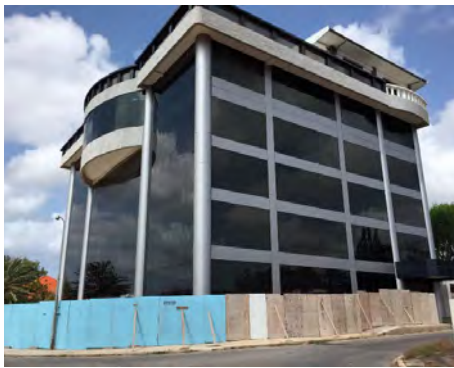
Fig. 6. Building to be investigated, Curacao 2014

When the structural reliability of a building is under discussion, it is of importance to be aware of the most advanced measuring techniques in order to be able to judge upon the bearing resistance of the structure. A special case is shown in Fig. 6a. The picture shows a new building on a Caribbean island just before finalization. However, the developer went bankrupt, and the building became the property of the bank. When the bank investigated the state of the building, it turned out that during the construction the builders had decided to build one story more than initially planned. Moreover, it turned out that there were no drawings of the cross-sections of the columns so that the reinforcement in the columns was unknown. Finally, there were no data on the strength of the concrete.
